Article: ASA-17-01C

2016 - 2017 Sportsman 450HO / 570 1-UP Optional RH Side Panel Close Off Kit

2016–2017 SPORTSMAN 450/570 1–UP HEAT MANAGEMENT KIT

P/N 2207445

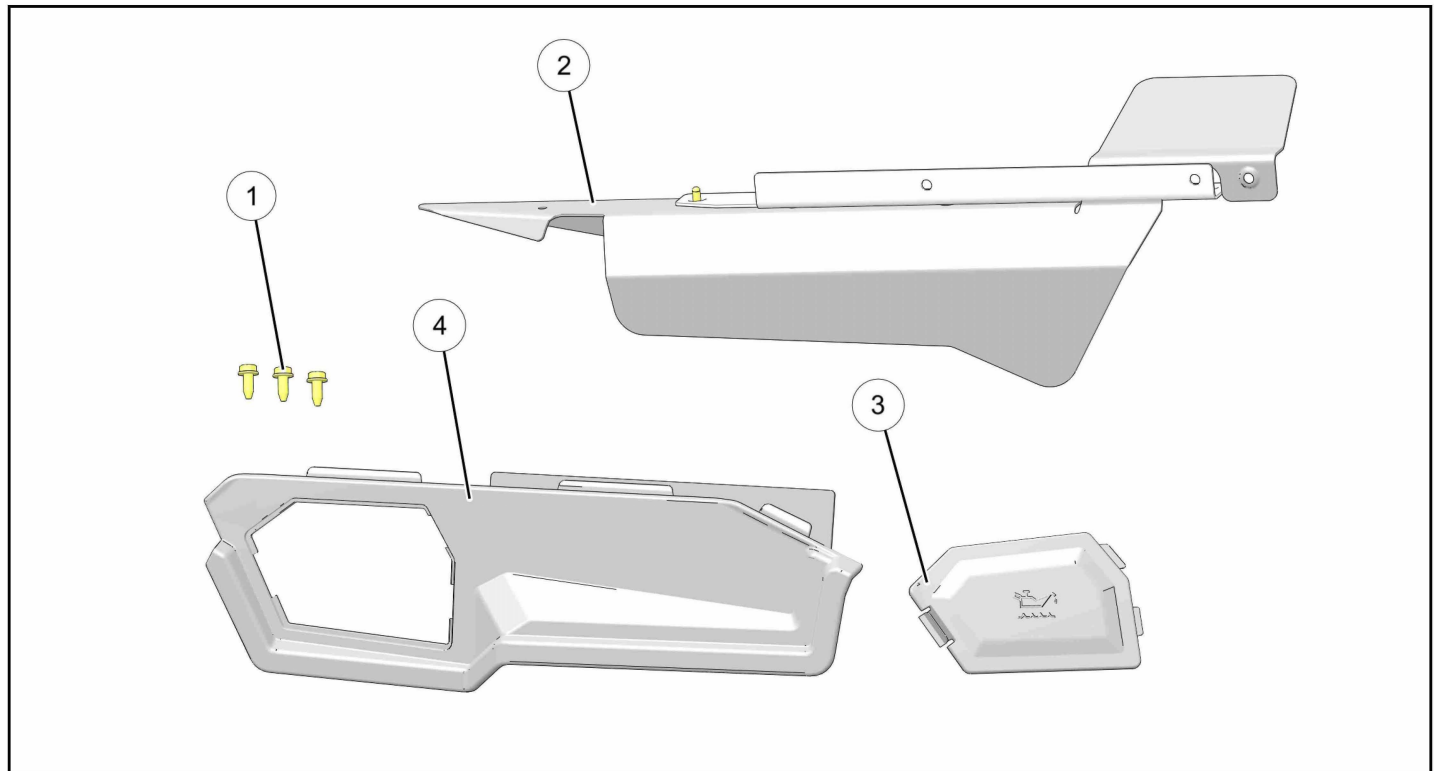
KIT CONTENTS

| REF | QTY | PART DESCRIPTION | PART NUMBER |
| 1 | 3 | Screws | 7517386 |
| 2 | 1 | ASM - Shield, Airbox | 2636957 |
| 3 | 1 | Panel Access- RH | 2637041–070 |
| 4 | 1 | ASM - Close Off/Shield, RH, Basic | 2636955–070 |

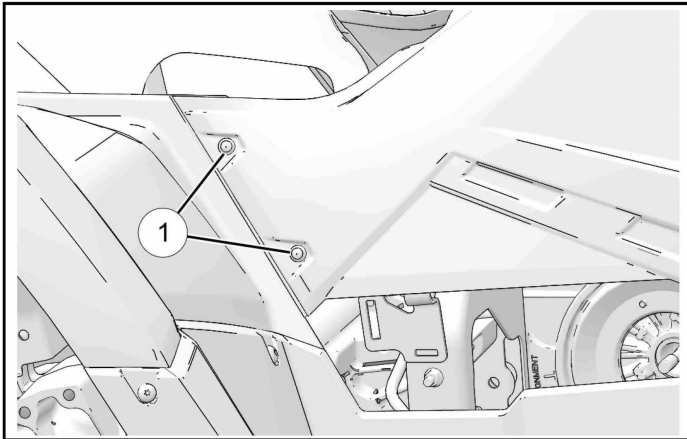
1. Place the vehicle in park. Turn the vehicle off, and remove the key from the ignition.
2. Remove the seat.
3. Remove the two Tuflok rivets ① retaining the rear of the right side panel.

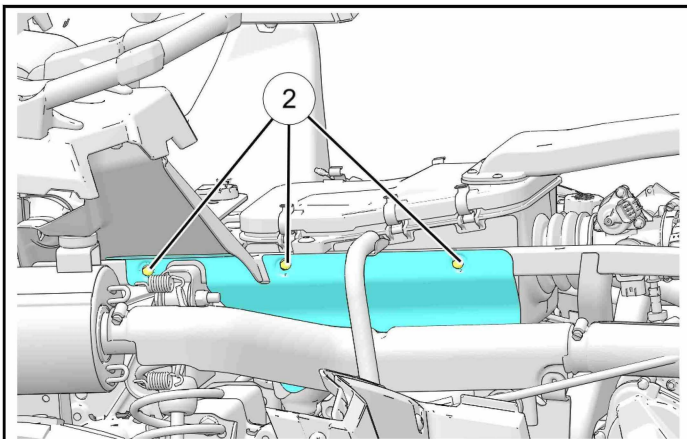
5. If an existing air box shield is present, remove the three 3/8 inch (10 mm) fasteners ② and remove the shield. Discard the old shield.

The three mounting holes in the new air box shield align with the holes for the old air box shield. If the mounting holes are not present they will need to be drilled for the new heat shield.

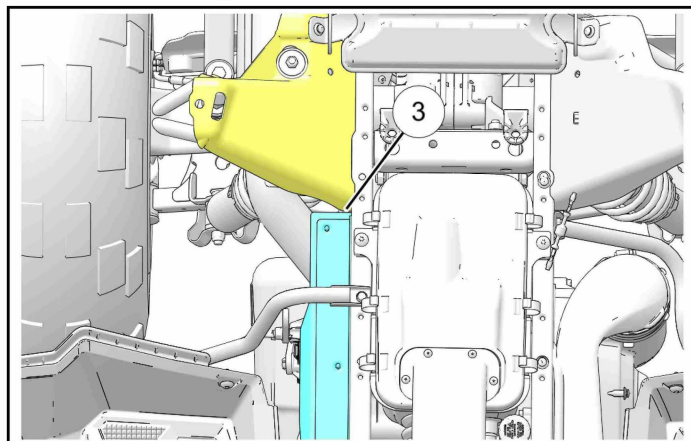
7. Guide the new heat shield (P/N 2636957) over the exhaust pipe and line up with the edge of the shock tower ③ as shown.

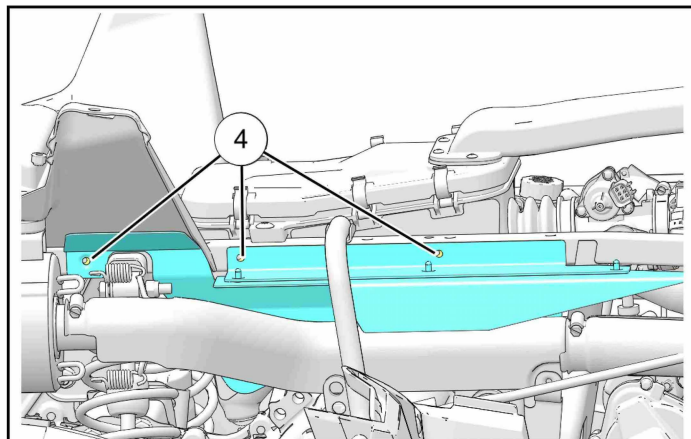
8. Mark the location of the mounting holes ④ in the heat shield with a center punch. Remove the shield and drill the marked mounting holes with a 3/16 inch drill bit.

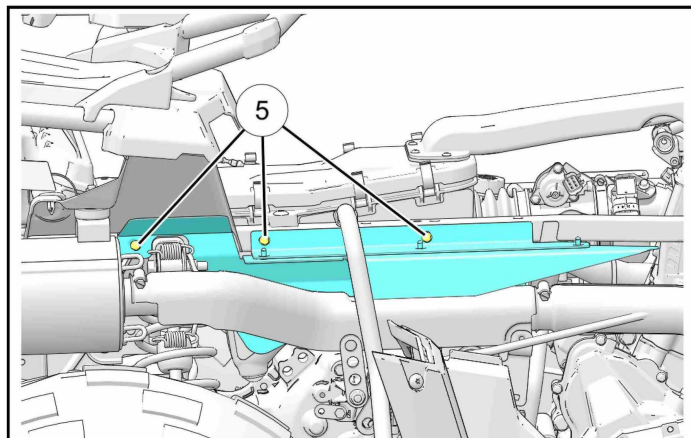
9. Guide the new heat shield (2636957) over the exhaust pipe and line up with the mounting holes.
10. Install the three self tapping 3/8 inch (10 mm) heat shield retaining bolts ⑤ (P/N 7517386) into the mounting holes on the frame. Torque until fully seated.

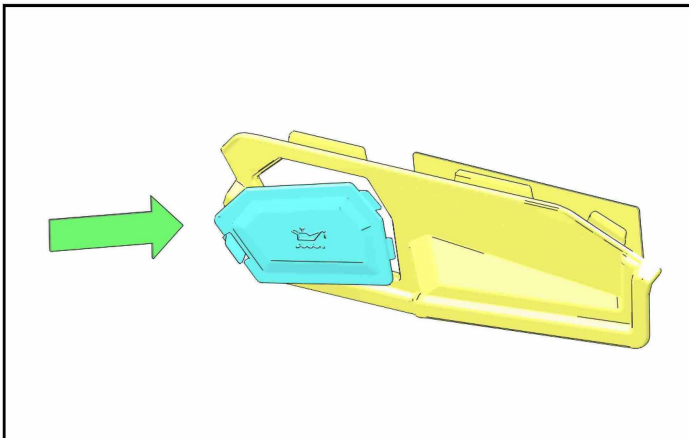
1. Install the access panel (P/N 2630741-070) into the close off panel (P/N 2636956-070) by inserting the tabs into the close off panel as shown.

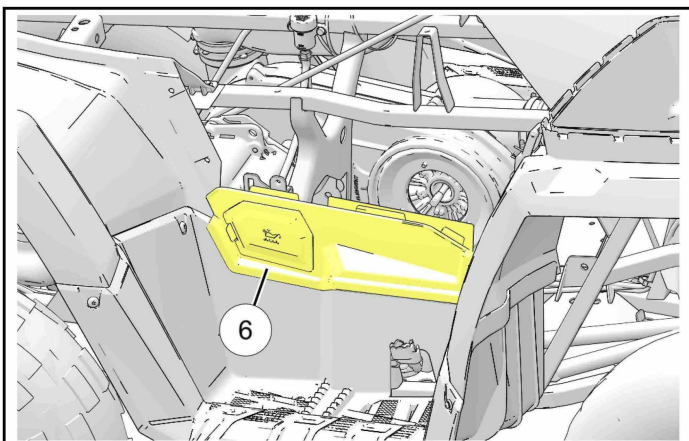
2. Install the new assembled close off panel ⑥ into the right hand foot well as shown.

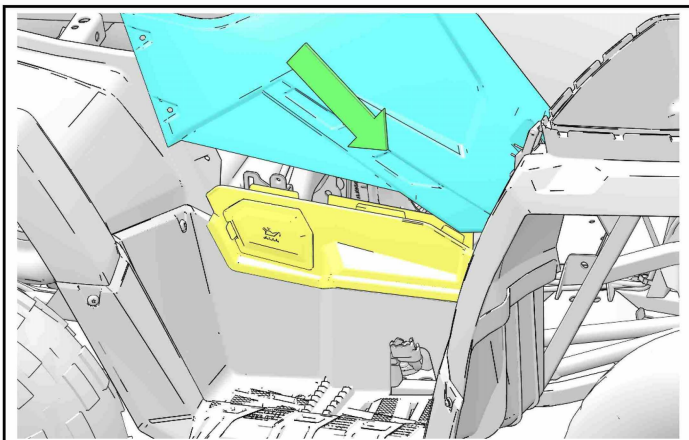
3. Align the side panel grooves with the front cab and slide the side panel down into the grooves of the close off panel.

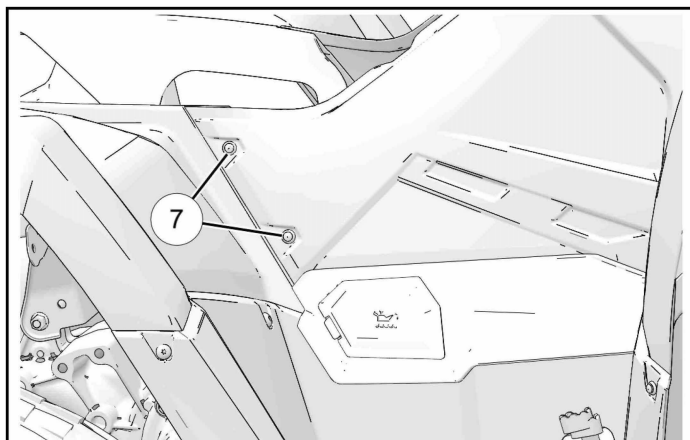
4. Ensure the side panel grooves are aligned with the front cab and close off panel.
5. Install previously removed Tuflok rivets ⑦ to secure the right side panel to the rear cab.
